## Chapter 2 - Site Inventory and Analysis

### **Identification of Plan Boundary / Project Limits**

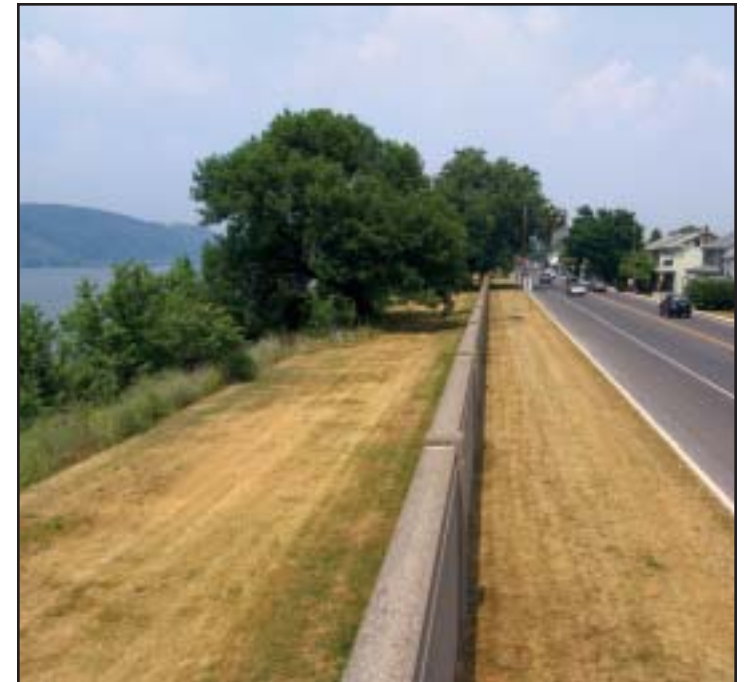
*Flood wall along Front Street.*

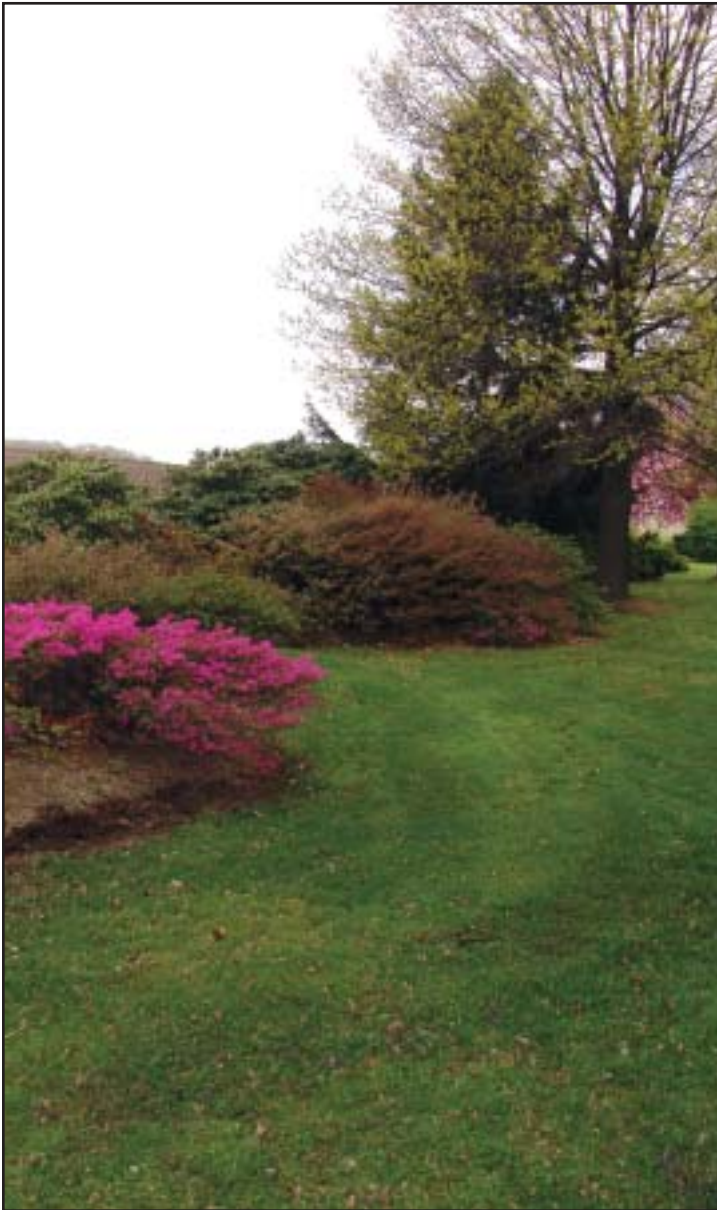
*Plantings at Merle Phillips Park.*

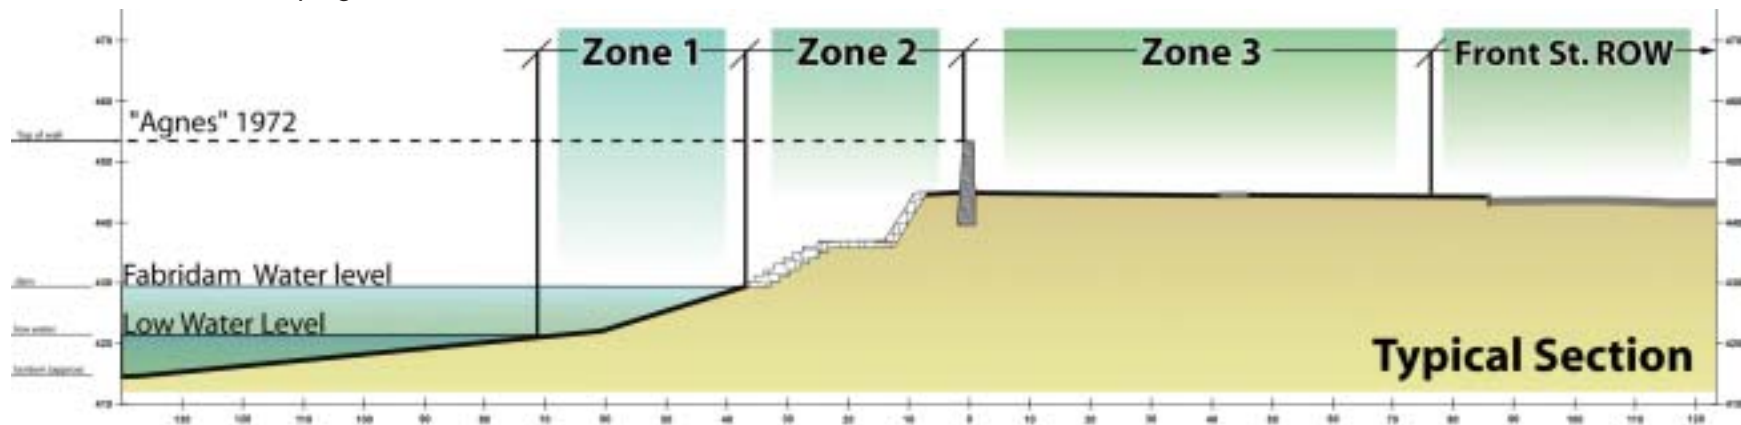
*Site analysis zones.*

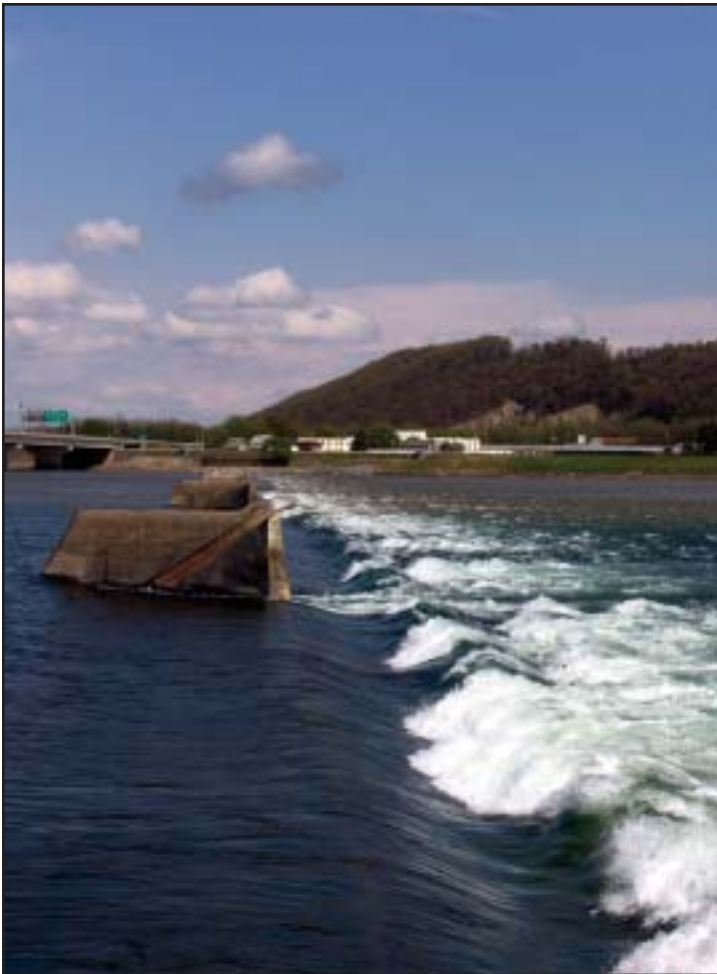
*Fabridam deflated looking across to the proposed fish ladder site.*
